IRAQI ARMY FACILITIES
UNDER THE IRAQ SECURITY FORCES FUND
DIYANAH AND DEBECHA, IRAQ

SIGIR PA-07-114
JANUARY 17, 2008

SUBJECT: Report on Construction and Renovation of Iraqi Army Facilities at Diyanah and Debecha, Iraq (Project Number SIGIR PA-07-114)

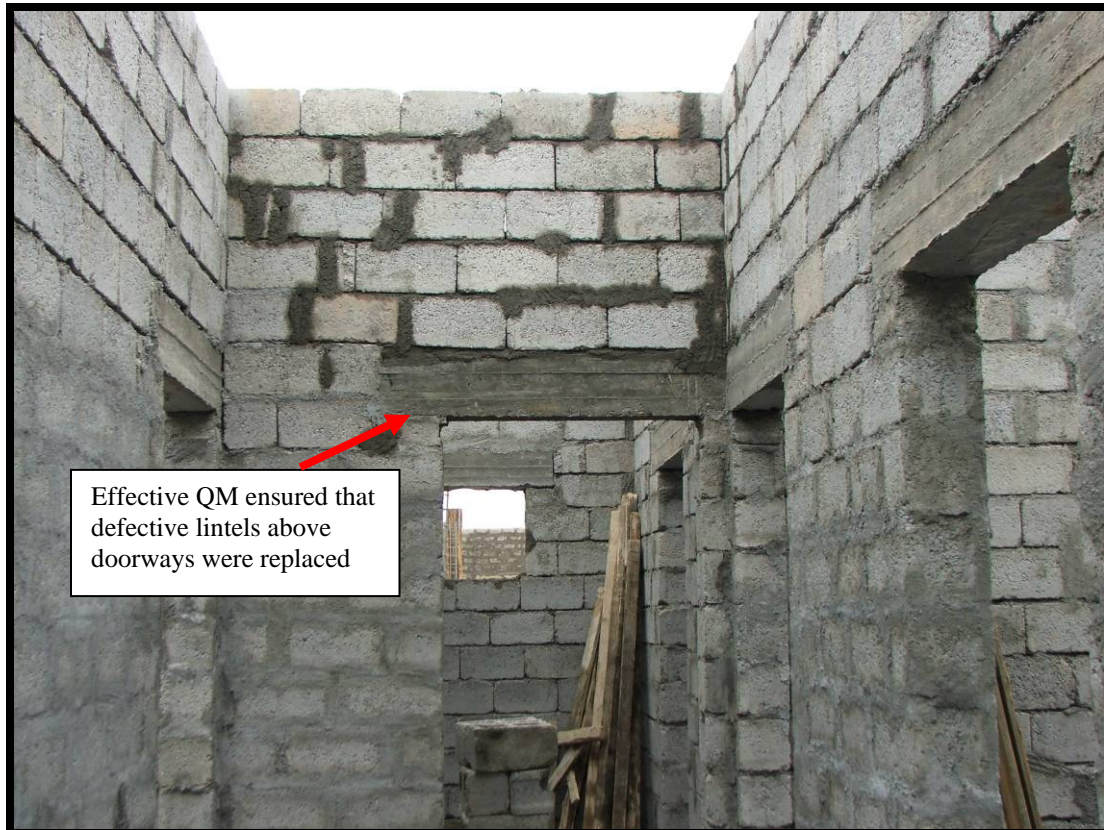
Both QA and QC reporting at Debecha were adequate and effective. For example, the Title II Daily Quality Report dated 21 November 2007 documented that two substantive deficiencies should be addressed. The report cited that lintel beams were not properly placed above openings in block walls (doors and windows) and that backfill and compaction processes were not in accordance with the SORS. The QC and QA personnel have worked together to resolve both issues.

Site Photo 1 shows one of numerous lintel beams throughout the project that was reworked and cast-in-place to comply with specifications. Site Photo 2 shows where backfill and compaction process have been modified to comply with specifications². Subsequent compaction tests verified by an independent laboratory confirmed that soil compaction requirements were met.

Site Photo 1. Subcontractor reworked lintels.

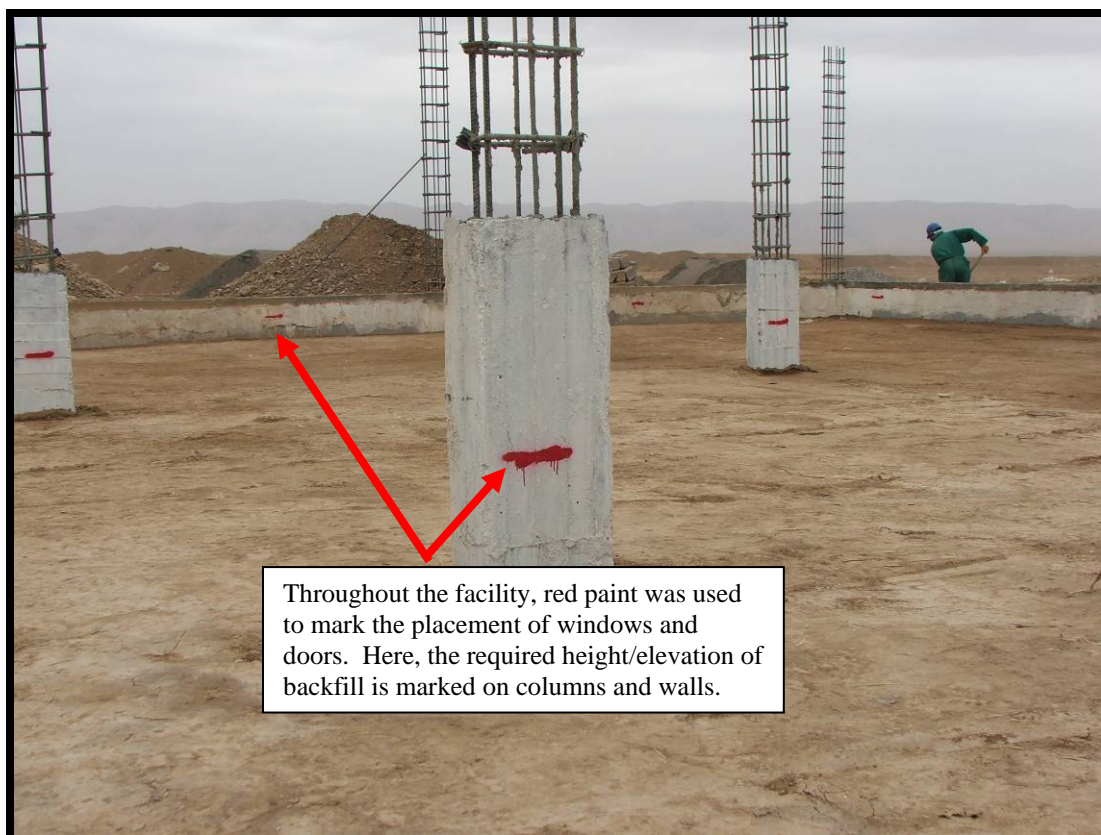
² Specifications required that backfilled layers of soil should be compacted every 20 centimeter (7.8"). However, the Title II representative cited that some layers were as thick as 35 centimeter (13.8"). Accordingly, initial laboratory test results confirmed that some backfill soil was not sufficiently compacted.

Site Photo 2. Backfill requirement marked.

To improve processes to backfill and compact soil, the contractor purchased field soil testing equipment (Kessler Dynamic Cone Penetrometer) to estimate the strength characteristics of fine and granulated soils³. To date, QM practices have been effective and provide for reasonable assurance that construction quality at Diyanah and Debecha should be acceptable.

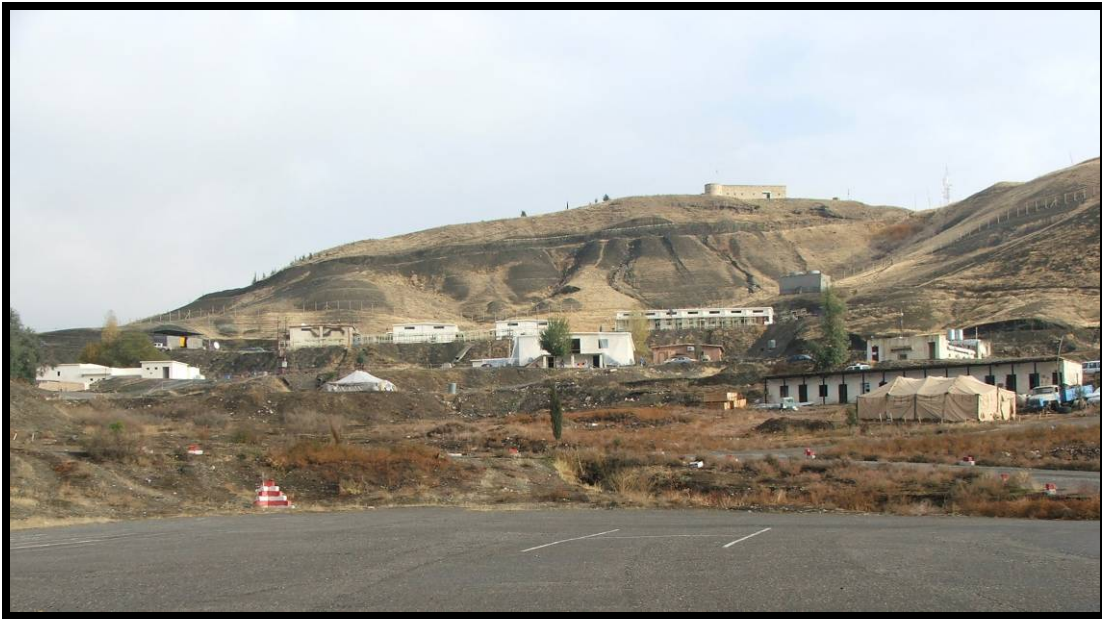
Land and soil conditions between the Diyanah and Debecha facilities varied considerably. Site Photo 3 shows a portion (about half) of the Diyanah project where the bulk of the work involved the renovation of existing facilities that were structurally sound, but in disrepair. Although the Diyanah site was on a hillside, required pre-construction site excavation or preparation was not extensive because most of the work involved the renovation of existing facilities. The project did call for some new construction; however, planned building sites were previously excavated and flat and should not offer any unusual challenge to the contractor.

Soils at Diyanah were medium clay and coarse sand and there was evidence of some past erosion. Prior to starting the project, some soil had washed and lodged against walls on the up hill side of several buildings. The contractor's Senior Program Manager stated that a drainage plan that included retaining walls had been submitted to the government for consideration in accordance with contract terms.

Site Photo 3. North half of Diyanah facility.

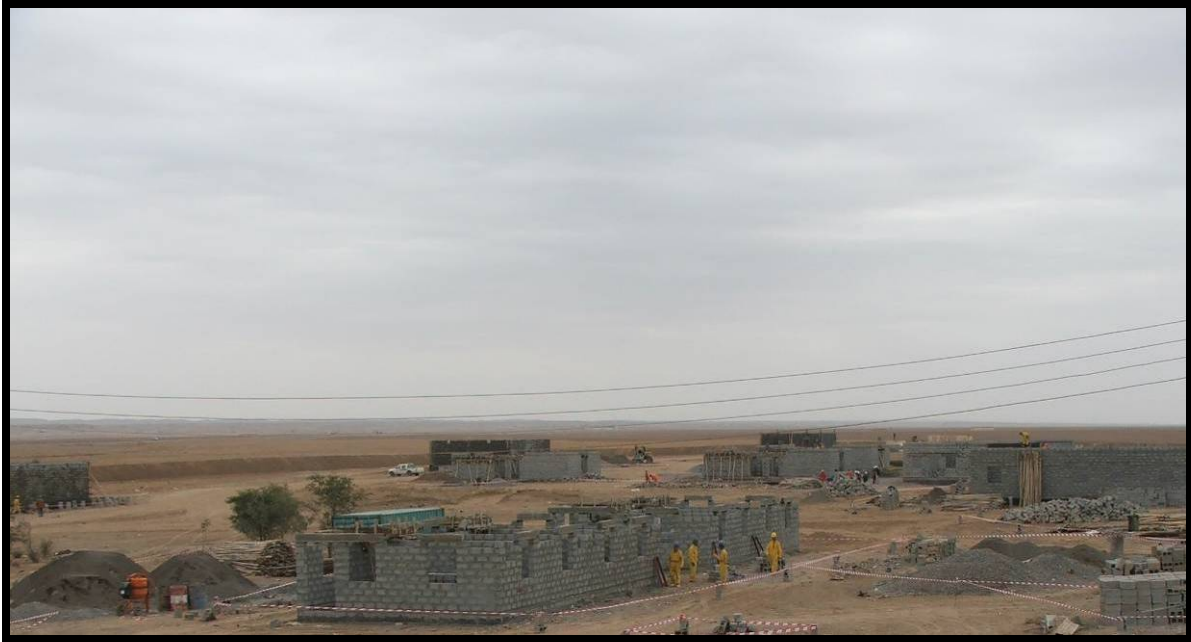
Site Photo 4 shows a portion (about a quarter) of the Debecha project that is comprised almost entirely of new construction. The topography at Debecha was very flat and offered no unusual site preparation challenges.

Site Photo 4. Debecha construction activity and flat building site.

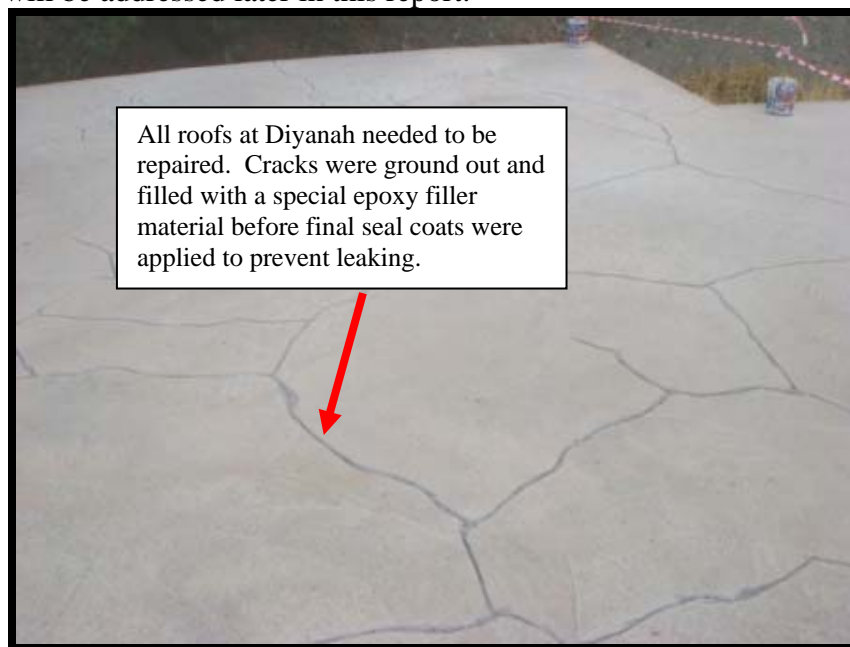
Based on the contractor's technical survey of the Diyanah site, roofs throughout the complex of buildings were in a deteriorated condition prior to renovation. As a result, there was interior water damage to numerous buildings. Site Photo 5 shows an example of existing cracks in roofs most likely caused by shrinkage of the original concrete roof casting. In addition, expansion joints in the original construction were improperly designed and had to be removed, redesigned, and reconstructed. Subsequent repairs and renovation will be addressed later in this report.

**Site Photo 5. Before repair, water leaked through cracks in the original roof.
(Photo courtesy of Toltest)**

Some of the original roof edge castings were too high and precluded complete drainage allowing water to leak through cracks in the original roof. To correct the problem, the contractor cut away high edges and grouted to a level that would ensure proper drainage. The roof was inspected by contractor and subcontractor managers before the roof was

sealed with three coats of a roll-on roof sealing material designed specifically for such applications. Site Photo 8 shows a roof top following renovation.

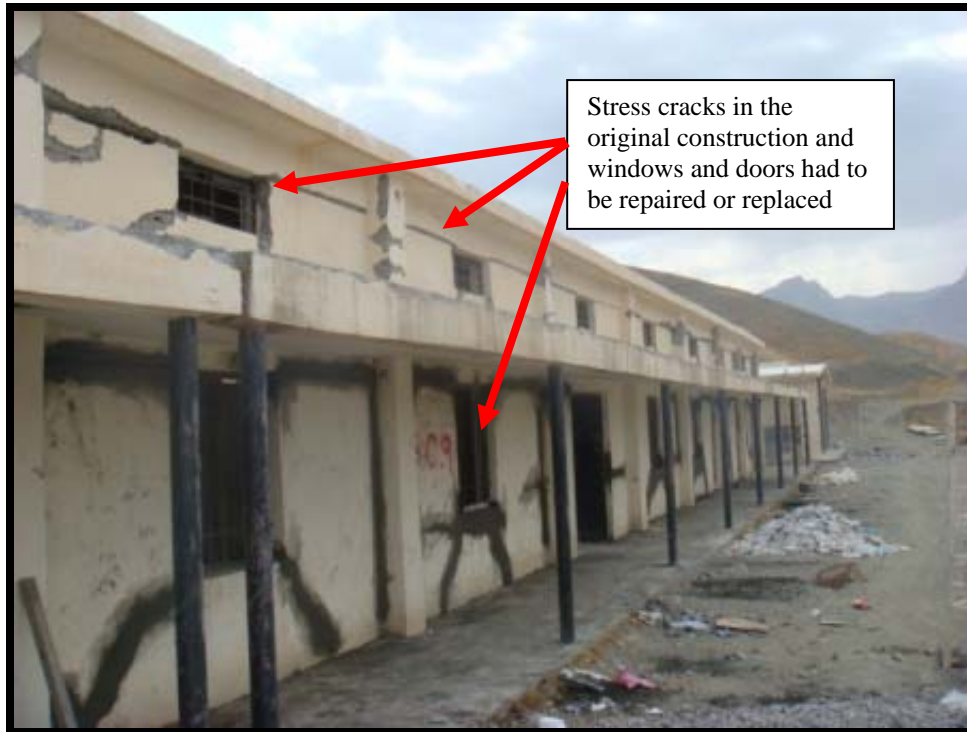
Site Photo 6 shows the “typical” exterior of buildings found to be structurally sound, but in disrepair before renovation at Diyanah.

Site Photo 6. Typical building exterior before renovation at Diyanah.
(Photo courtesy of Toltest)

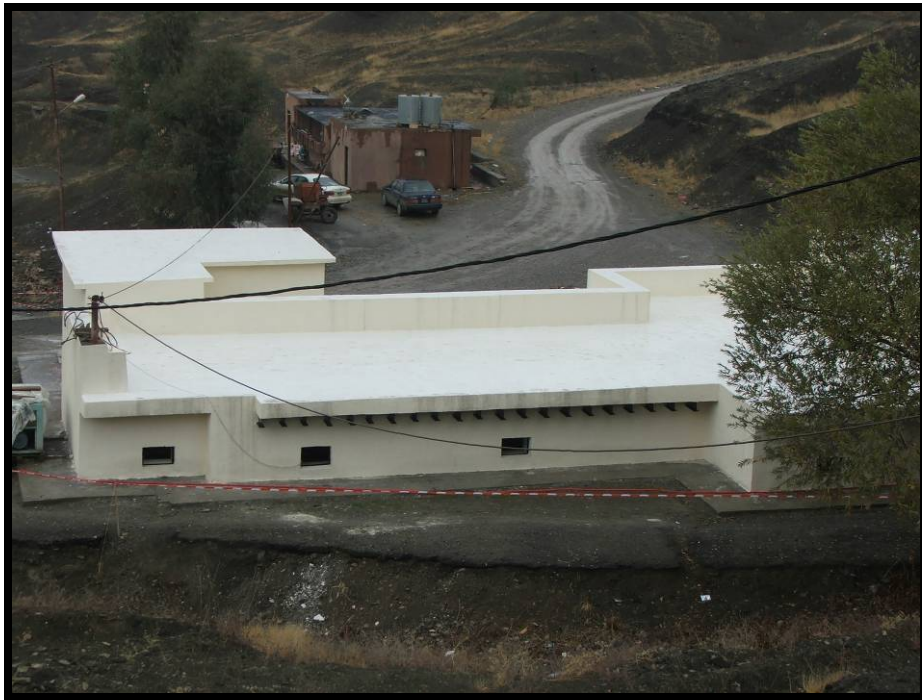
Site Photos 8 and 9 show a repaired roof and expansion joint. Site Photo 8 is representative of the condition of all roofs following renovation. The contractor explained and documented the processes used to repair the roofs throughout the facility. All cracks were opened with a grinder to remove loose material and to obtain a beveled shape (wide at the top and narrow at the bottom). Subsequently, the ground-out cracks were inspected and then filled with an epoxy filler designed for such applications.

Site Photo 8. Typical roof top following renovation.

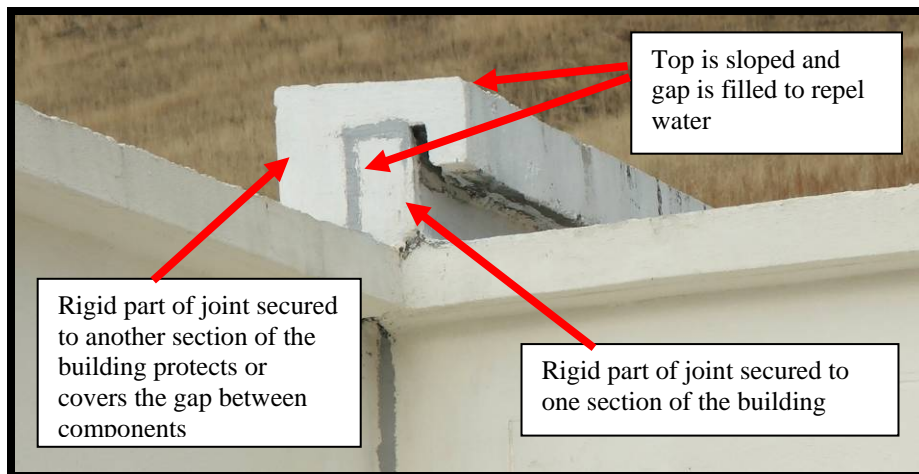
Site Photo 9 shows an expansion joint after renovation. The design of the expansion joint and application of a sealer between the building sections should ensure a water tight joint.

Site Photo 9. Renovation included replacing poorly designed original expansion joints that leaked.

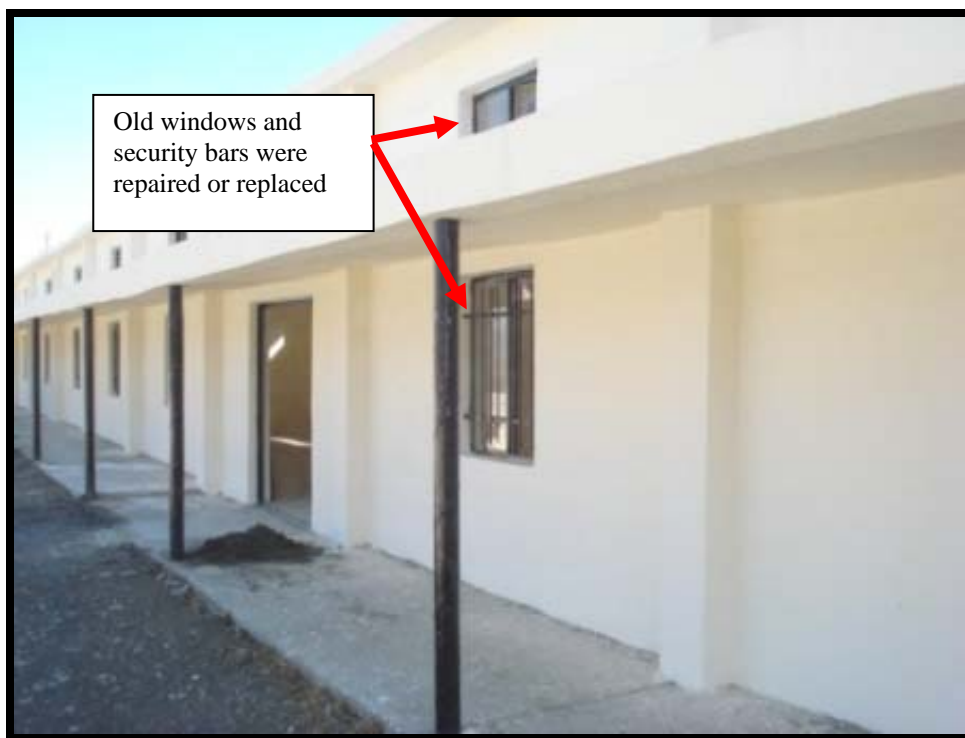
Site Photo 10 is representative of buildings following renovation including exterior painting. Substantial repair work preceded the final exterior painting process. Site Photo 11 shows where workers repaired cracks and removed loose exterior plaster/stucco. Large sections of damaged or loose stucco were replaced with new plaster/stucco in preparation of exterior painting. Patch work over cracks and flat surfaces was covered with wire mesh to ensure bonding between the original wall and the fresh plaster/stucco.

Site Photo 10. Typical building exterior following renovation. (Photo courtesy of Toltest)

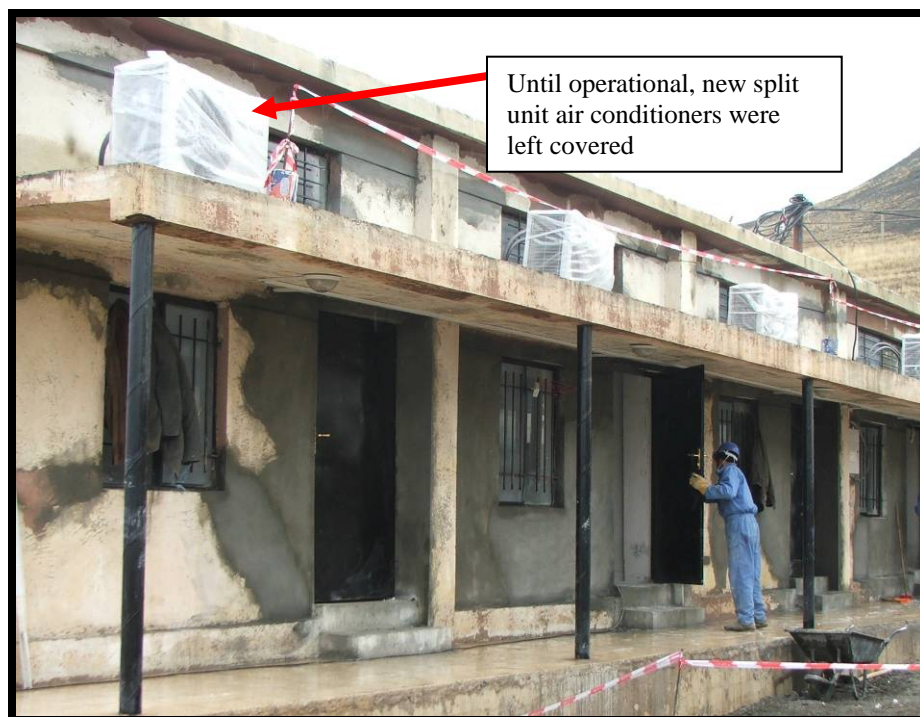
Site Photo 11. Exterior renovation work in progress.

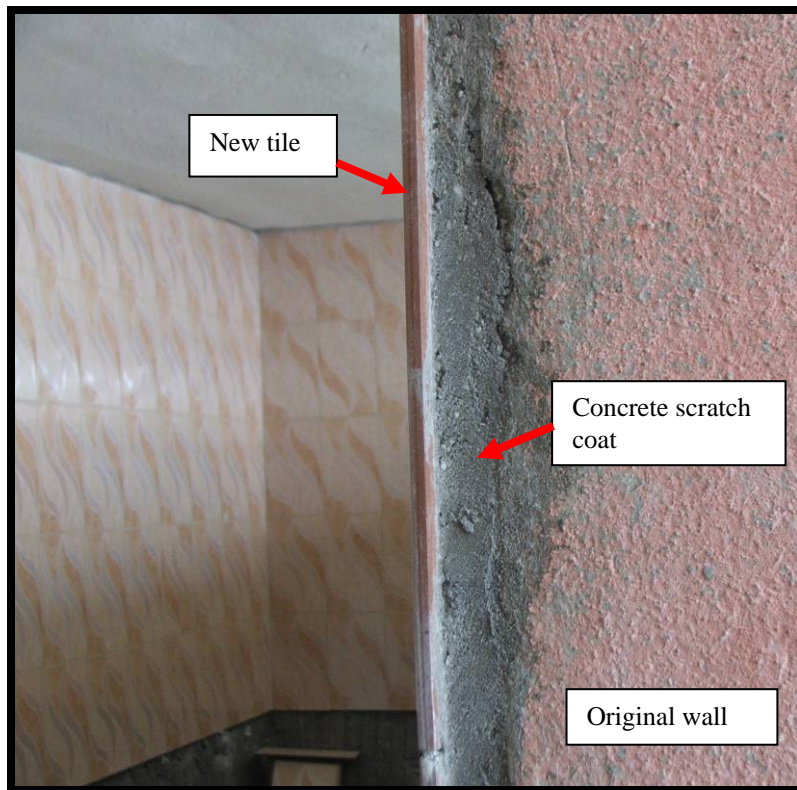
In accordance with contract requirements, tile was used to cover the walls in high water use areas. Site Photo 12 was taken in the food preparation area of one of the two dining facilities at Diyanah. The photo shows that loose material was removed from the original wall. Then a scratch coat of concrete was applied to form a uniform surface for subsequent tile installation. All tile work observed was satisfactory. All tile joints were

exactly horizontal or vertical and evenly spaced the entire length of the tile because plastic spacers manufactured to uniform dimensions were used. The plastic spacers were placed in the corner of each tile ensuring alignment with the three other adjacent tiles. In addition, the walls were flat.

Site Photo 12. Wall tile work was high quality throughout facility.

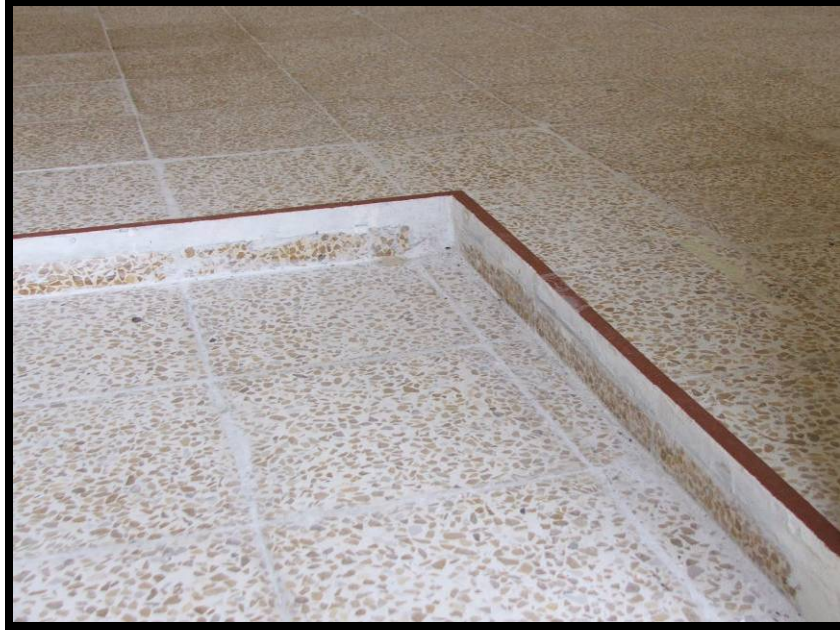
While not all tile floors were yet installed in those areas that required Terrazzo tile, SIGIR observed that work completed to date was satisfactory. Individual Terrazzo tiles were reasonably level and joints were evenly spaced and parallel between adjoining rows of tile. Site Photo 13 shows an example of a Terrazzo tile floor following initial installation.

Site Photo 13. New Terrazzo floor included lowered entry area.

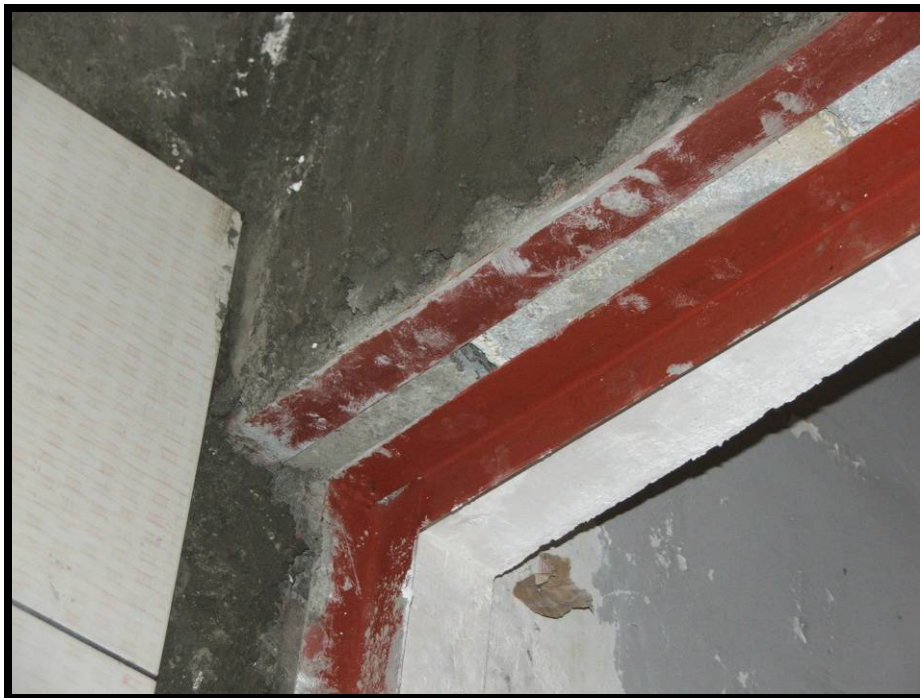
Window frames were renovated and steel door frames were installed. Site Photo 14 shows a steel door frame installed in a food handling area. All door frames appeared to be properly installed. Specifically, the frames were tight, square, and grouted flush with the wall. Therefore, once the doors are installed they should swing level. In addition, SIGIR observed a number of exterior doors with new latch hardware that was compliant with SORS requirements. The hardware was cast of a heavy and hard metal alloy. In addition, the lock assembly was a keyed dead bolt independent of the latch mechanism. Such a design offers durability not generally found in locksets where the latch assembly also functions as the lock.

Site Photo 14. Typical steel door frame installation.

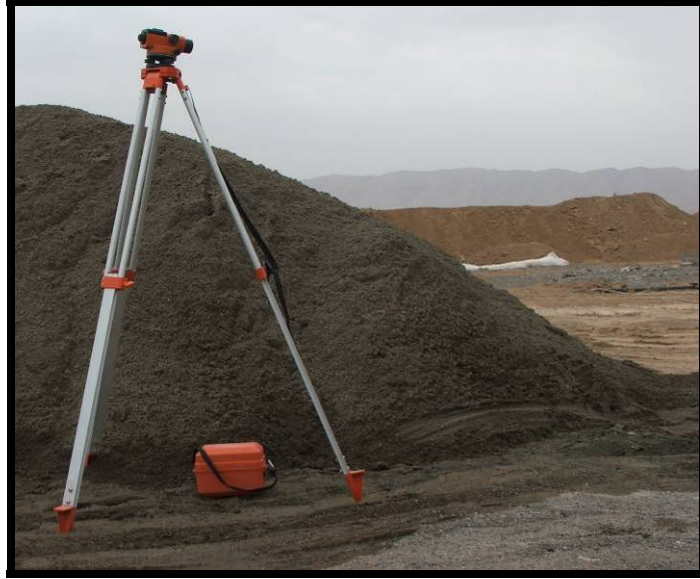
Site Photo 16. Transit was setup and ready when needed.

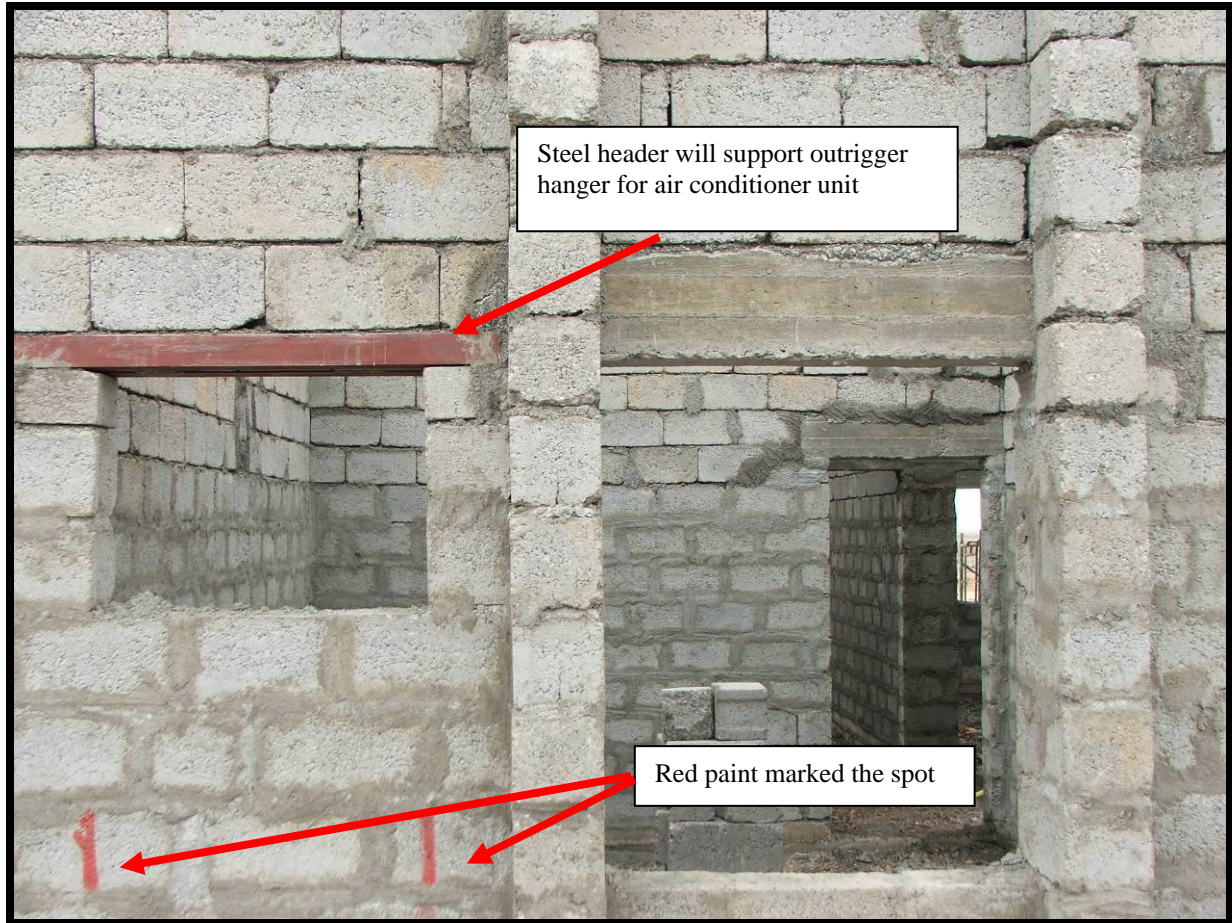
Red paint was used to mark specific measurements necessary for correct placement of window openings, air conditioning units, and elevations. For example, Site Photo 2 included earlier in this report shows that red paint was used to mark the final compacted grade or elevation height of the compacted backfill in the new dining facility. Similarly, Site Photo 17 shows that red marks were used to correctly place the opening for an air conditioning unit. This technique is a practical and effective way for the contractor's managers to observe completed work while lessening the likelihood of future mistakes.

Site Photo 17. Air conditioner location was marked by a supervisor.

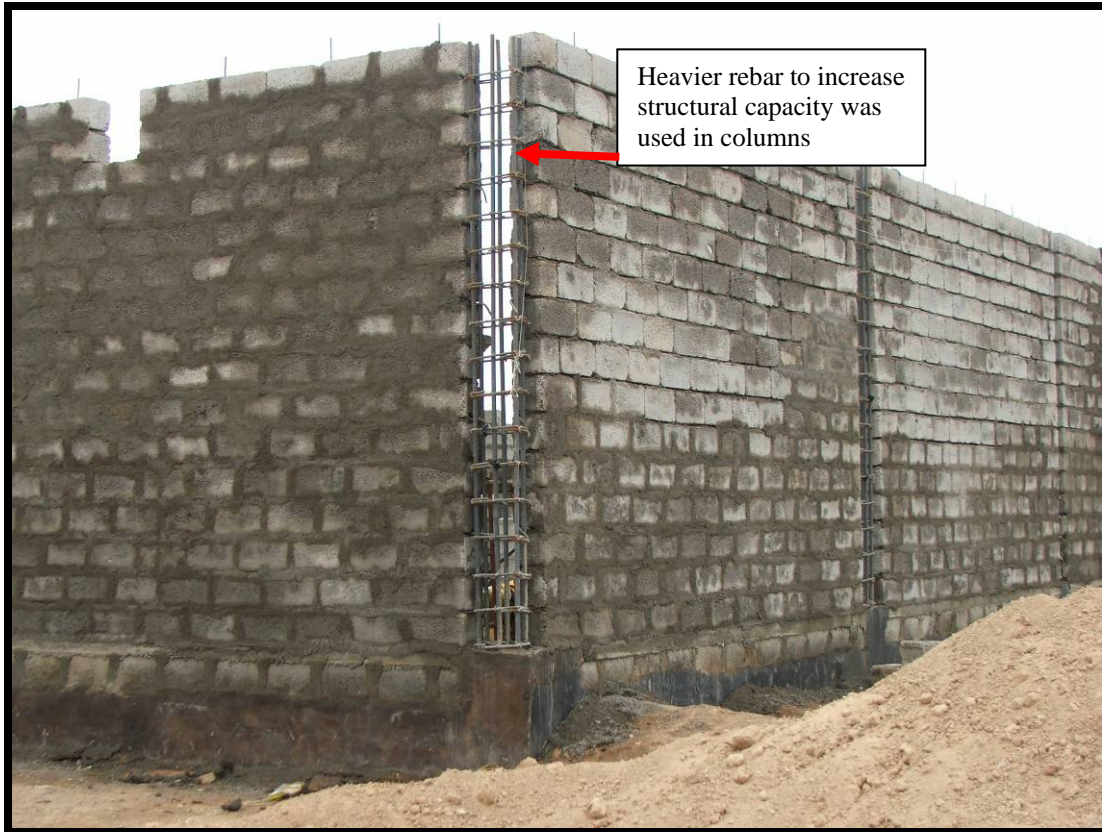
During the site visit to Debecha, SIGIR observed that several buildings were nearing the stage of construction where corner and wall columns would be cast following form work. Site Photo 18 shows the heavier reinforcement bars used in columns. After the columns are cast and sufficiently cured, workers will construct form work, install reinforcement bars and cast each building's roof flatwork and horizontal beams to complete the structural aspects of the roof system.

Site Photo 18. Typical wall construction before forming and casting columns.

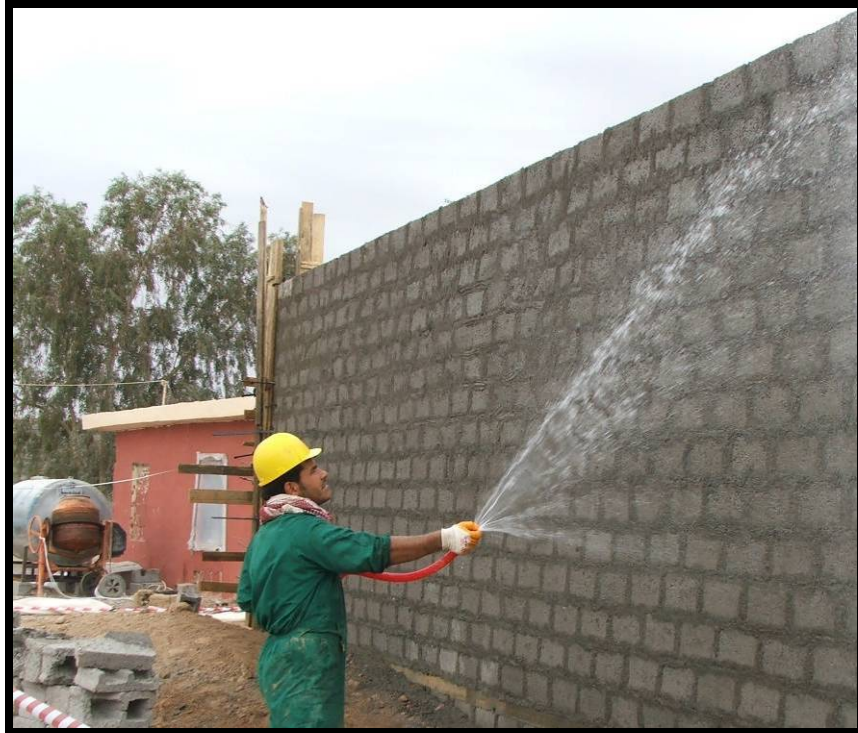
In Site Photo 19, a worker sprays water on the surface of a block wall to ensure that mortar used to fill cracks and spaces between blocks does not dry too fast and shrink. As a result, the walls will be a good surface upon which to apply finish exterior plaster/stucco.

SIGIR Photo 19. Walls were sprayed to prevent excessive shrink in joint mortar.

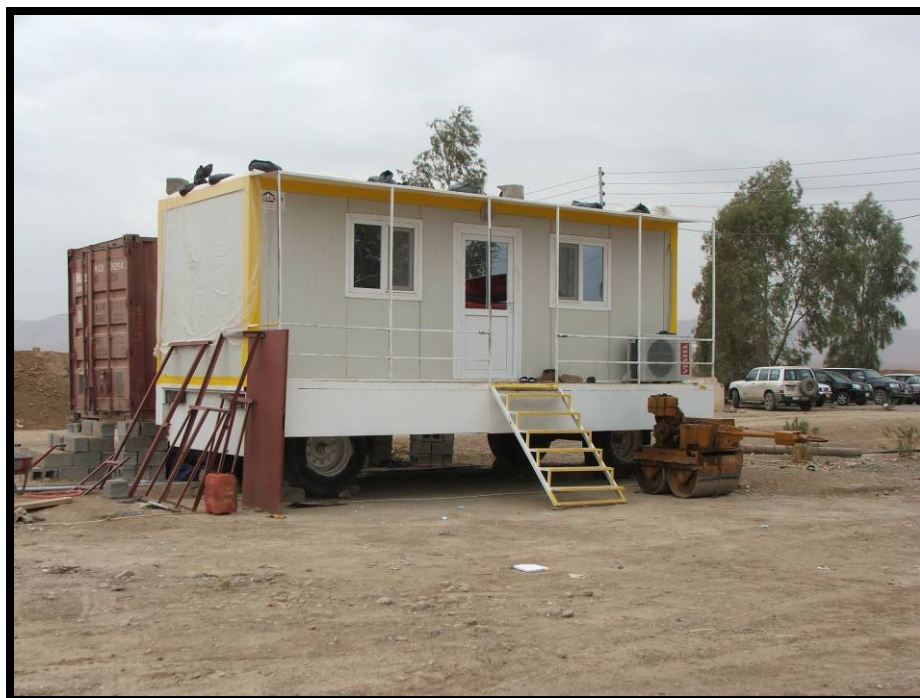
Site Photo 20 shows the construction office placed on site by the subcontractor for engineers and project supervisors. This will help the subcontractor fulfill its administrative and supervisory responsibilities.

Site Photo 20. Subcontractor construction office.
